FLUTTER TESTS OF MODIFIED SB2U MODEL
IN 16-FOOT TUNNEL

By Theodore Theodorsen, R. P. Coleman,
and N. H. Smith

Langley Memorial Aeronautical Laboratory
Langley Field, Va.

MEMORANDUM REPORT

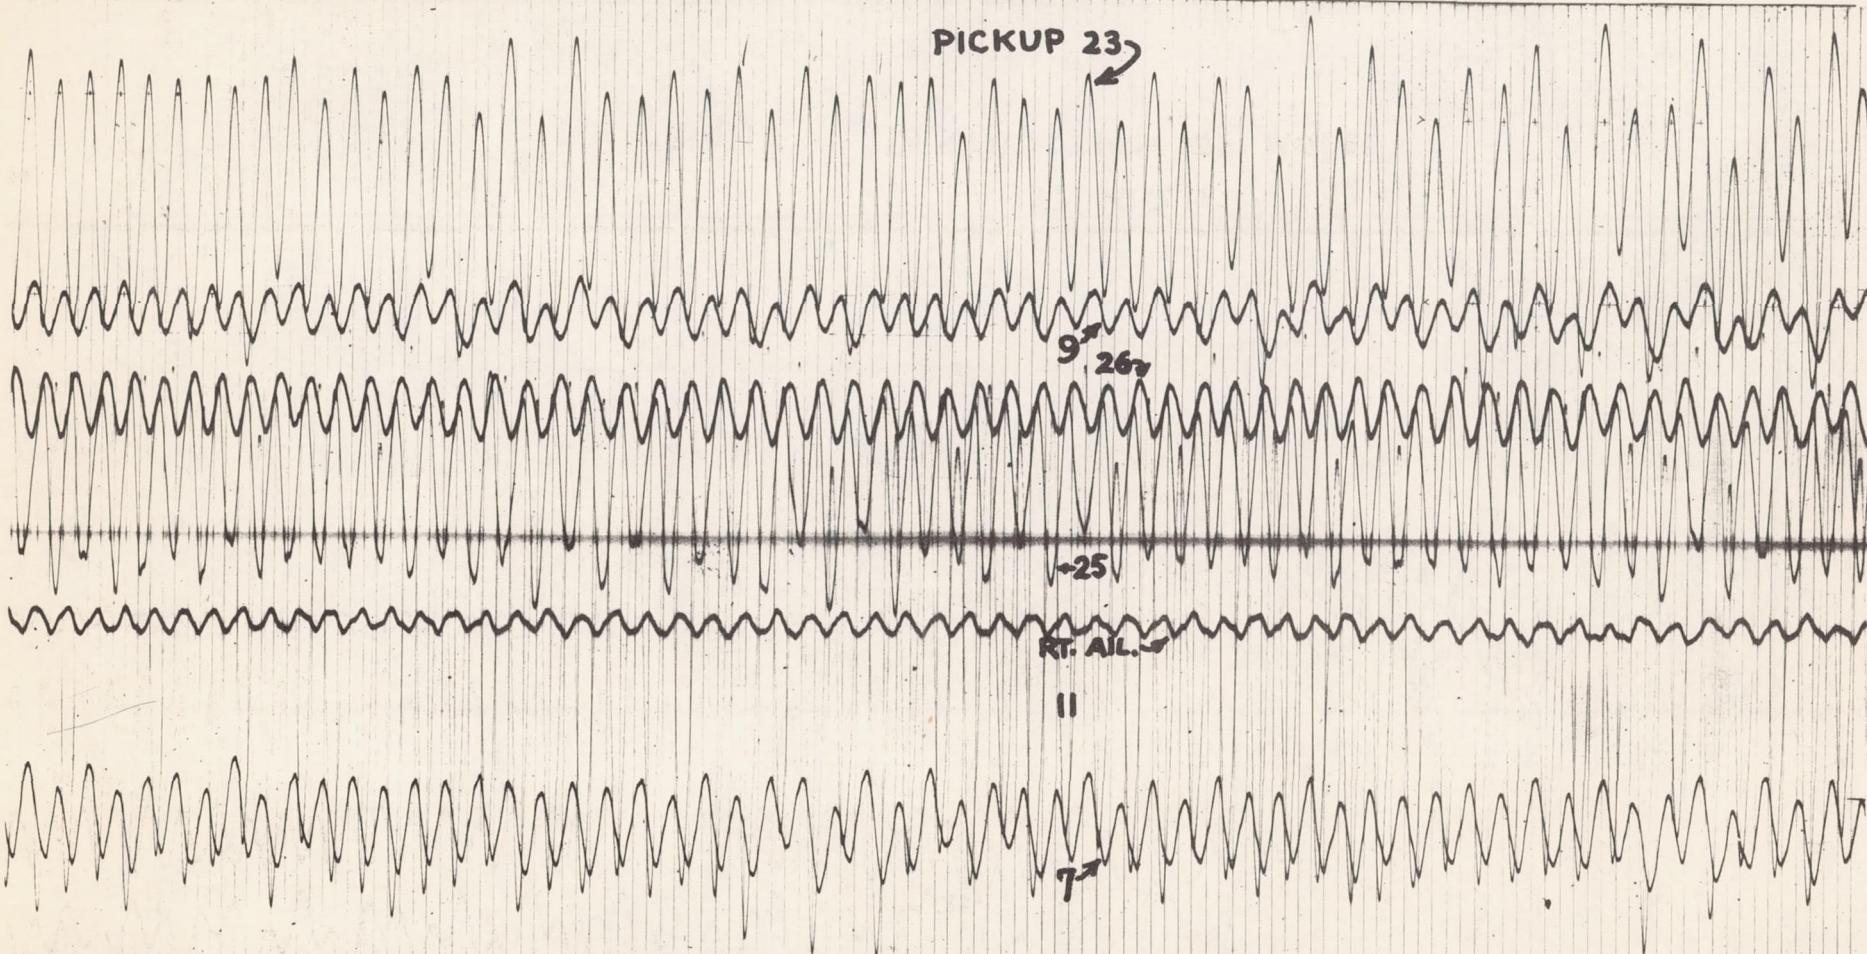
Fig. 16

7-14-43.- Same conditions as previous test. Runs were made at 0 and 120 miles per hour; then a continuous oscillograph record was taken with the vibrator stopped and the airspeed increasing from 130 to 150 miles per hour; then forced vibration records were taken at 140 miles per hour. In this speed range above 130 miles per hour a new high frequency vibration appears in the records. This response is intense enough to mask all the lower responses almost completely. It exhibits a strikingly constant frequency at a rather constant amplitude. The lower responses seem to penetrate sporadically to displace the high frequency mode. Occasional bursts of vibration at about 1000 cycles per minute can be observed on the records. (See fig. 15.) The last run was made with the air flow accelerating from a speed of 140 miles per hour to the speed of continuous flutter (157 mph). At this point the wing was destroyed by violent flutter. Oscillograph records were successfully obtained for the entire run. Parts of the record are reproduced in figures 16 and 17.

SECTION OF
ACCELERATION-TO-DESTRUCTION RECORD
VELOCITY INCREASED FROM 140 TO 157 M.P.H.
DURING RUN

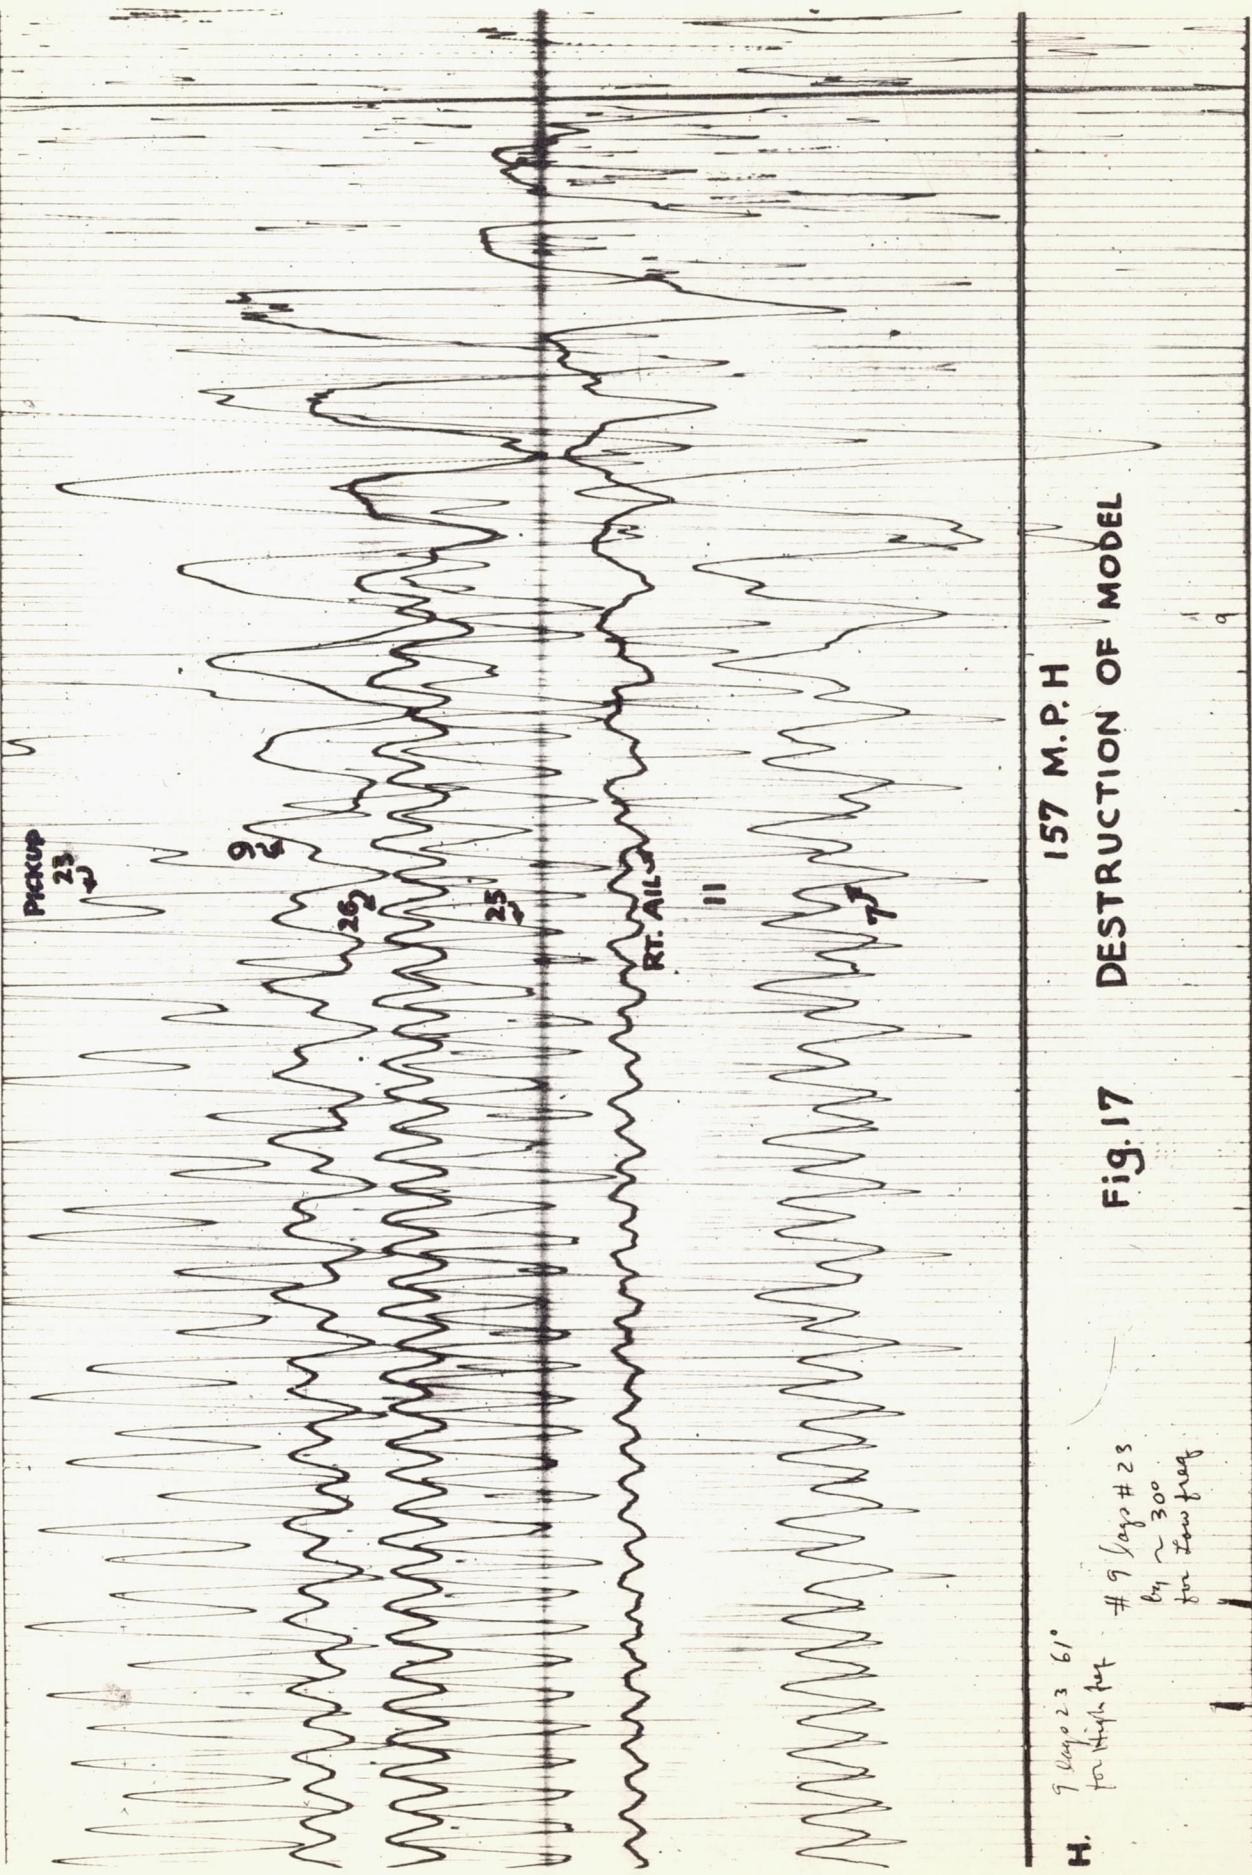
Fig. 17

157 M.P.H
DESTRUCTION OF MODEL

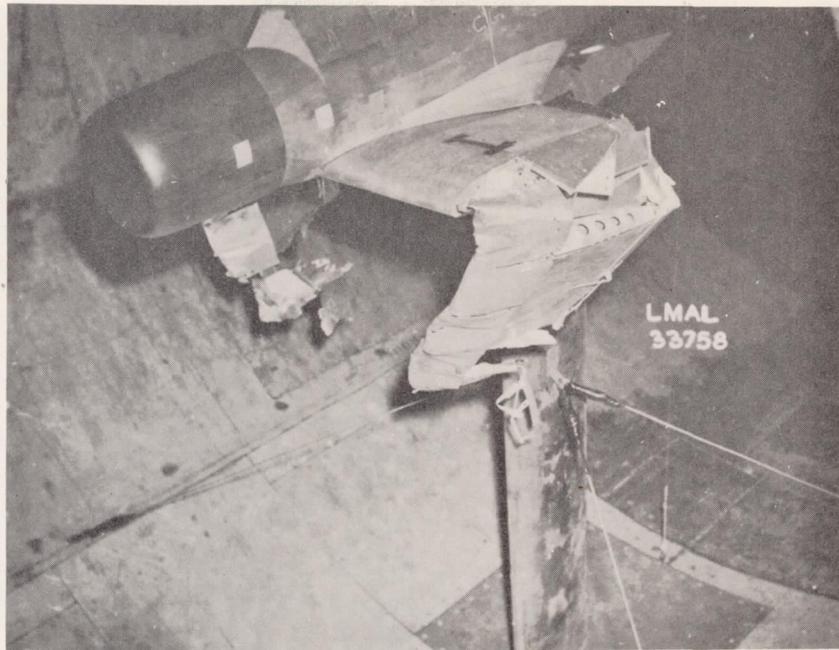
Tests were conducted at air speeds of 0, 50, 75, 100, 110, 115, and 120 miles per hour for each of the conditions tested. The conditions included changes of aileron spring stiffness and aileron balance. Records of forced vibration were taken at each of the airspeeds. In a final run to determine the actual flutter speed the model wing was destroyed by violent flutter at 157 miles per hour.

Pictures taken after the model had been destroyed by flutter are shown in figures 37 to 40.

Figure 37.- The wing after flutter.

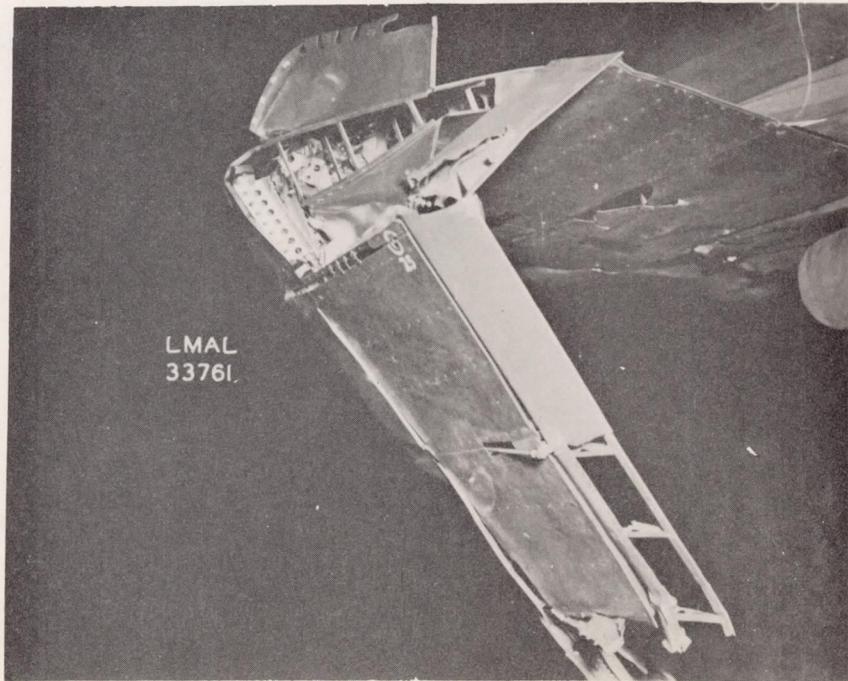
Figure 38.- The wing after flutter.

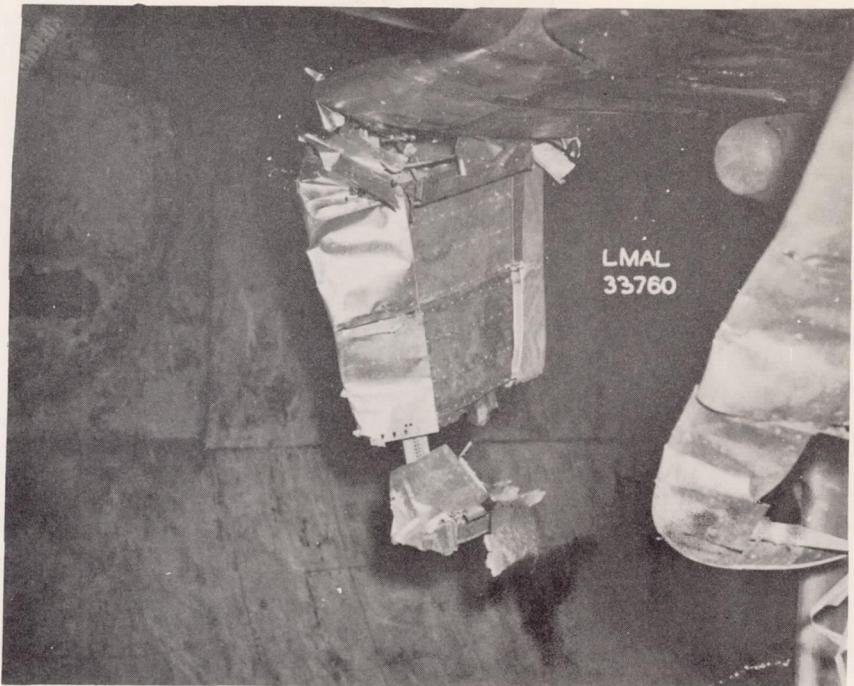
Figure 39.- The wing after flutter.

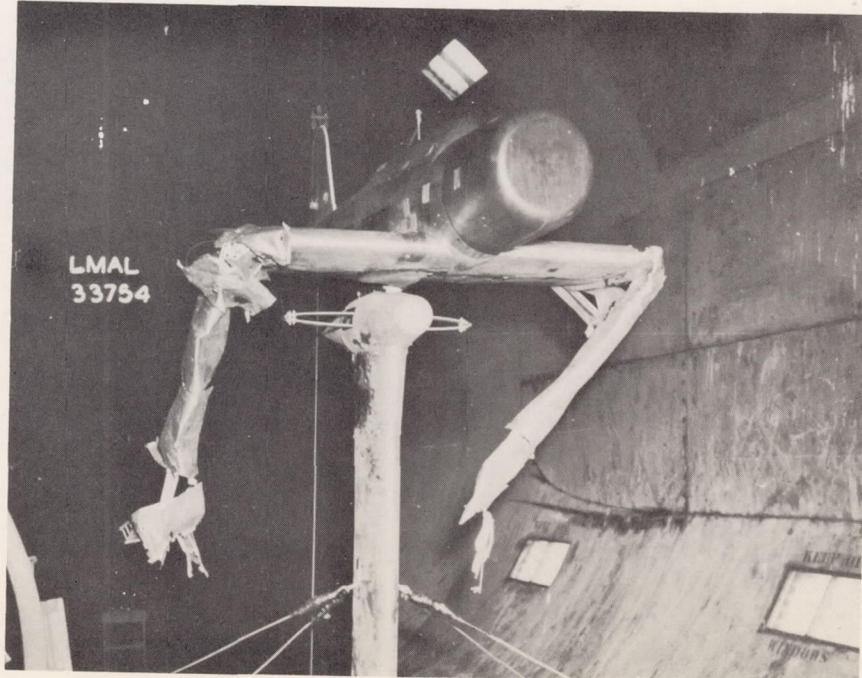
Figure 40.- The wing after flutter.
